## RYERSON STATION STATE PARK DAM

NDI I.D. NO: PA-193  
DER I.D. NO: 30-20

### PHASE I INSPECTION REPORT NATIONAL DAM INSPECTION PROGRAM

D'APPOLONIA CONSULTING ENGINEERS  
10 DUFF ROAD  
PITTSBURGH, PA. 15235  
MARCH 1979

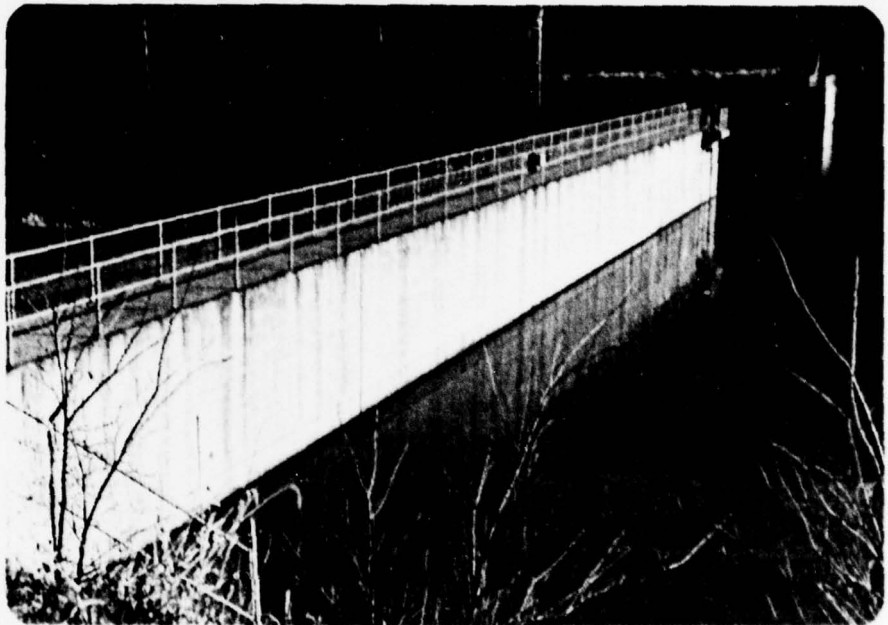
Upstream Face

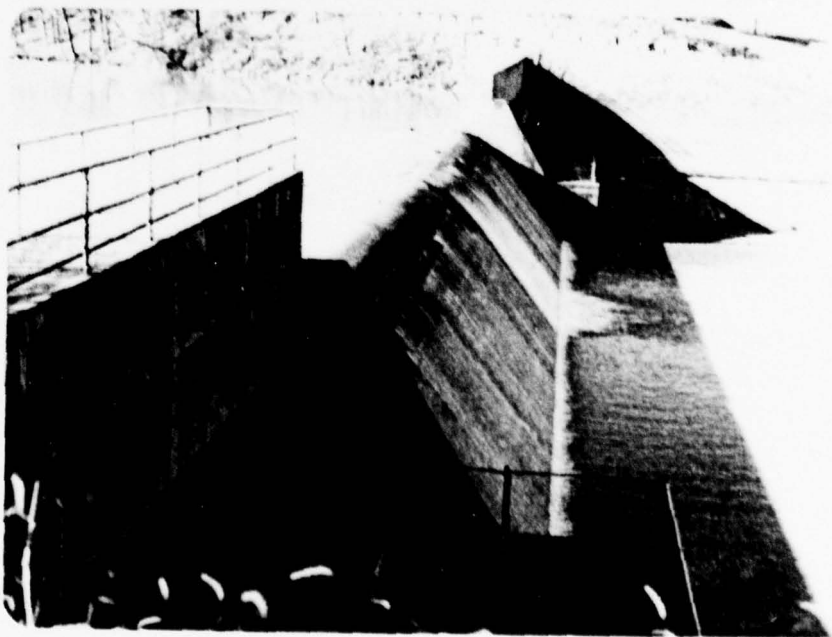
Downstream Face

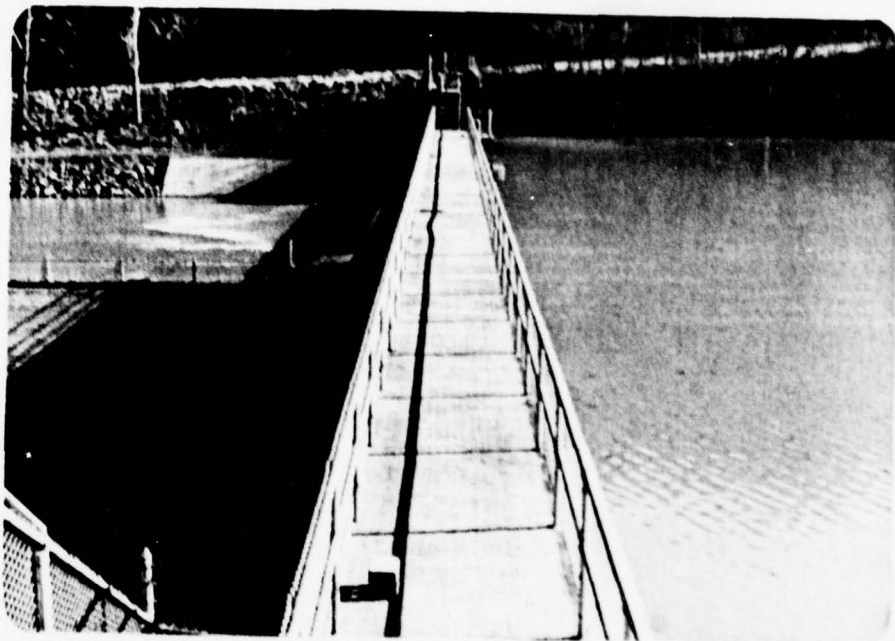
Photograph No. 1  
Crest (looking east).

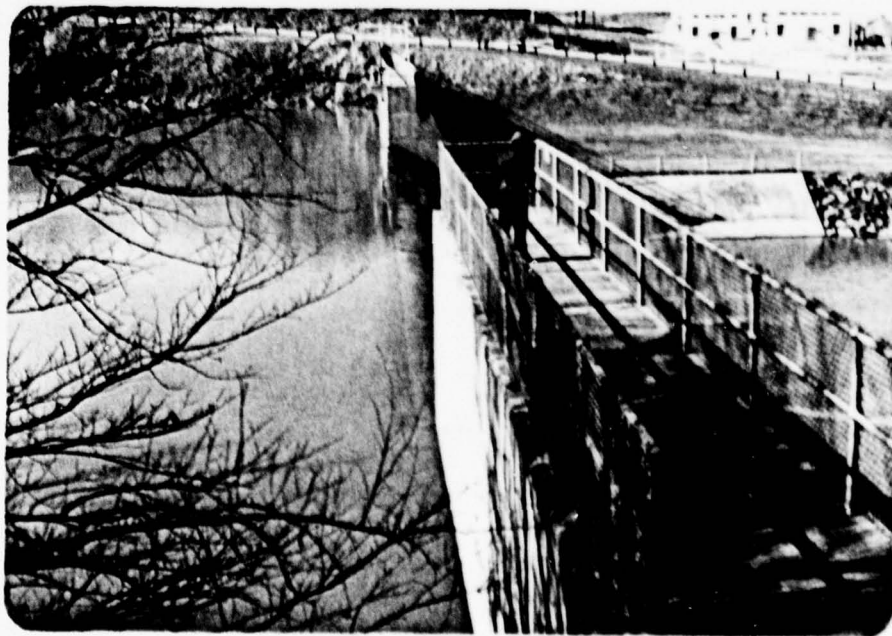
Photograph No. 2  
Crest (looking west).

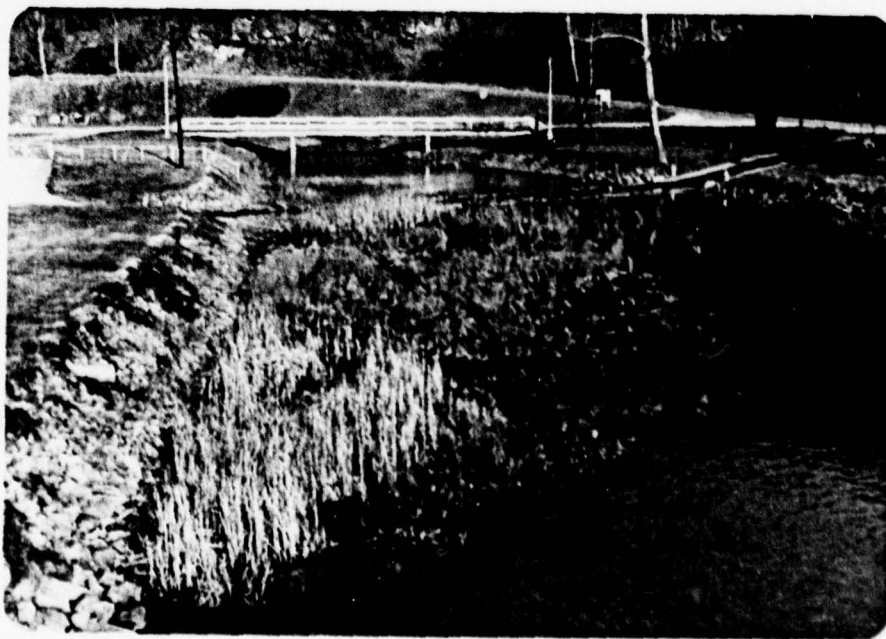
Photograph No. 4  
Spillway discharge channel.

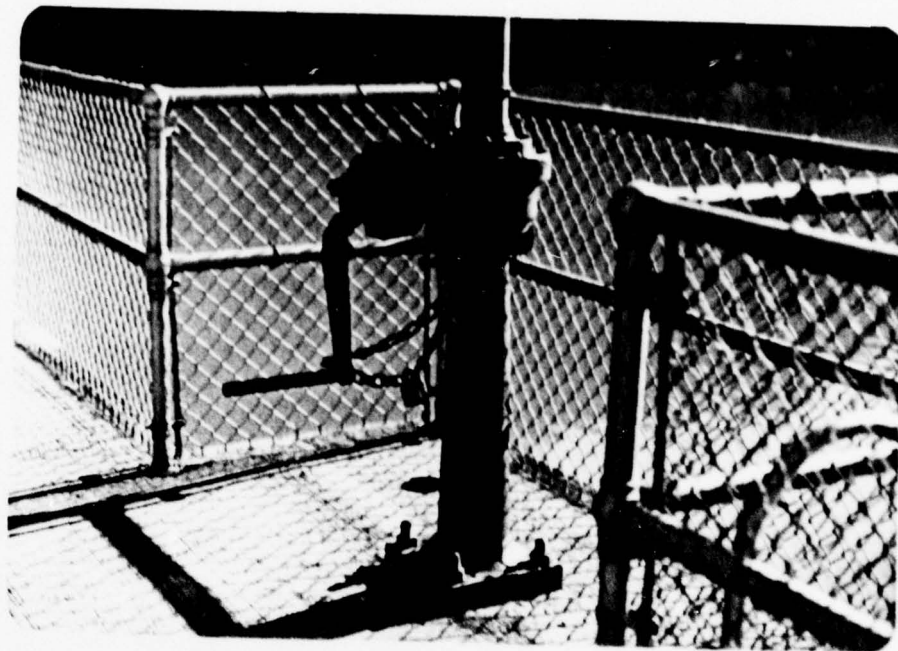
Photograph No. 5  
Outlet valve hoist.

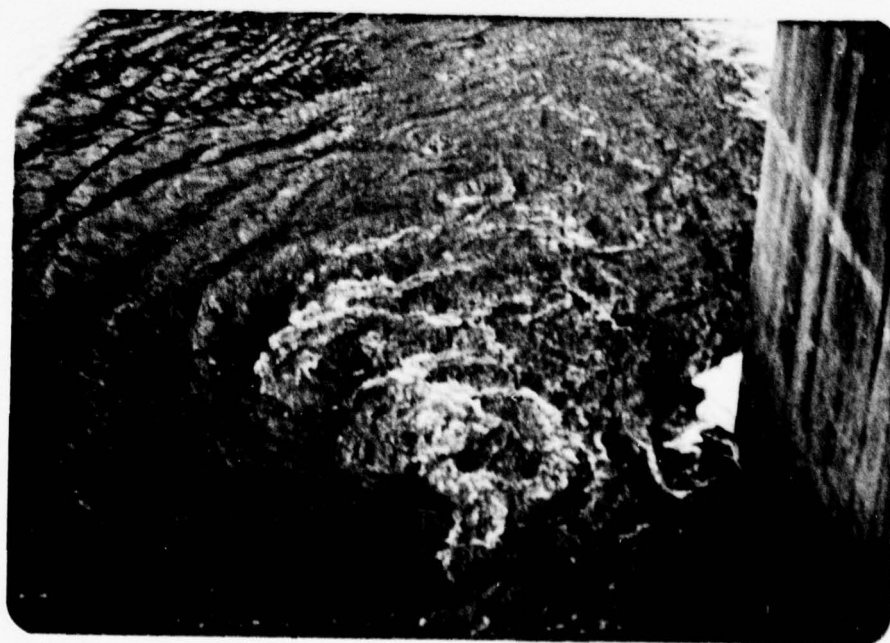
Photograph No. 6  
Outlet valve discharging (pipe is  
submerged).

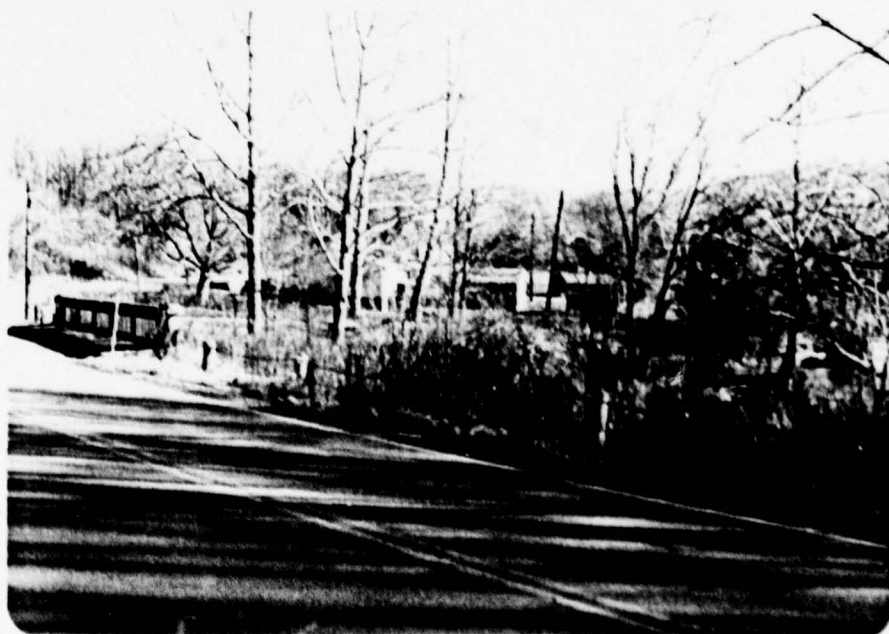
Photograph No. 9

Community of Ryerson Station (looking upstream).
